Technical Bulletin

Tension setting on Mitsubishi/Volvo 1.8 16V petrol engines

5514XS/K015514XS

MITSUBISHI / VOLVO

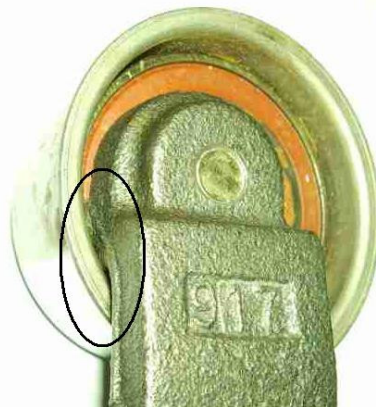
Fig. 2

- 1) Manipulating the tensioner correctly, but not completely following the recommended tension setting procedure. This leads to incorrect tension with a premature belt failure as a result.
- 2) Turning the tensioner in the wrong direction - clockwise. This leads to incorrect tension and very often tensioner seizure. The tensioner bracket touches the pulley, obstructing it to rotate freely (Fig. 2)

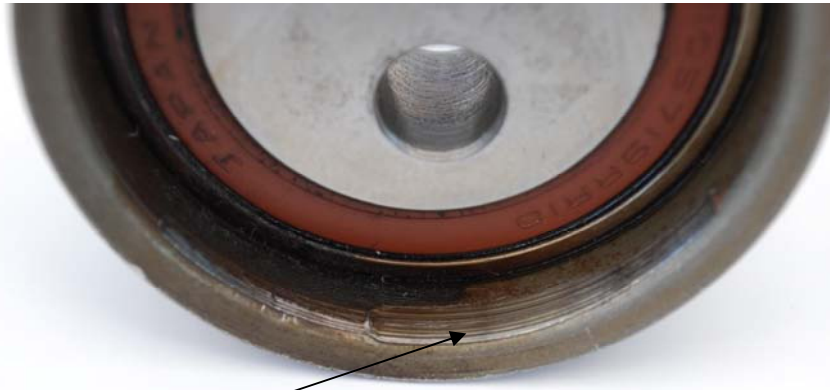
Fig. 3

Evidence of this can be found on the back inner side of the tensioner pulley. (Fig. 3)

Rubbing mark

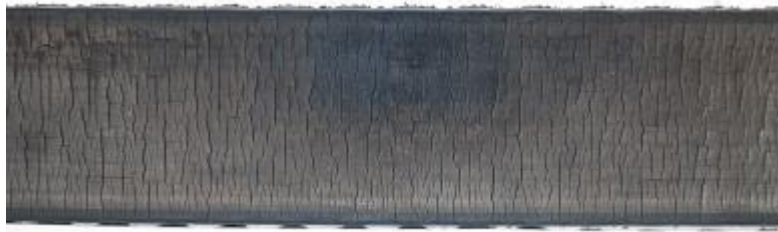
Fig. 4

Since the pulley cannot rotate anymore, the belt back - constantly rubbing against the pulley surface - will start to overheat and crack (Fig. 4).

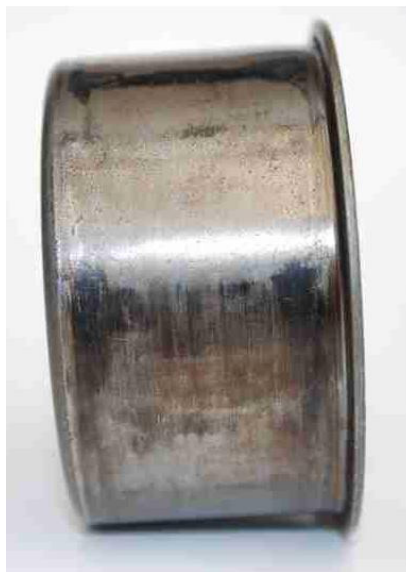
Fig. 5

This excessive temperature is further transmitted to the tensioner and idler pulleys, leaving a blue heat mark on the pulleys (Fig. 5), and possibly even traces of melted rubber (Fig. 6).

In general it is strongly recommended to replace the tensioner and idler pulleys together with the belt, as these parts obviously also wear out. A worn bearing (loss of grease, seizure, misalignment ...) is just as bad as a worn belt, and will lead to premature drive failure, resulting in serious engine damage.
