# Technical Bulletin

## Timing belt/kit installation on VAG 1.4/1.6 16V

<b>MAKE :</b>	AUDI, SEAT, SKODA, VOLKSWAGEN	
<b>MODEL :</b>	Various	
<b>ENGINE :</b>	1.4 16V, 1.6 16V	
<b>ENGINE CODE :</b>	Various

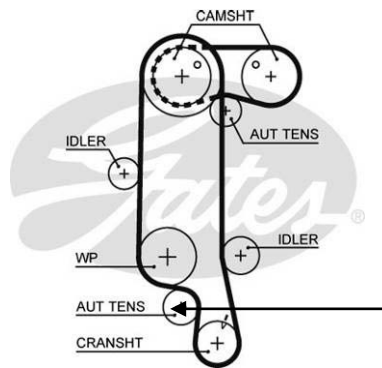
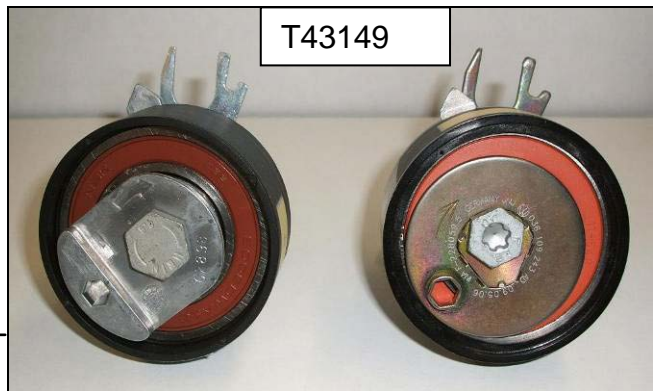
Fig. 1 shows the 2 different versions of automatic tensioner (for the main drive) which can be found in our kits. They are interchangeable.

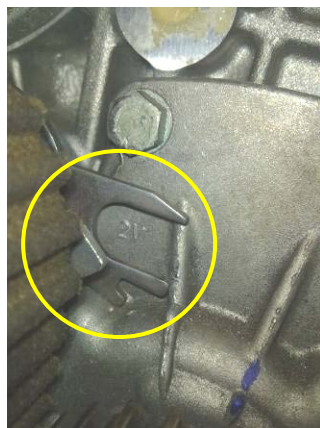
Fig. 2

It is clear an incorrect position of the locating lug (Fig. 2, 3 and 4) will lead to an incorrect belt tension or to the fact the belt cannot be tensioned.

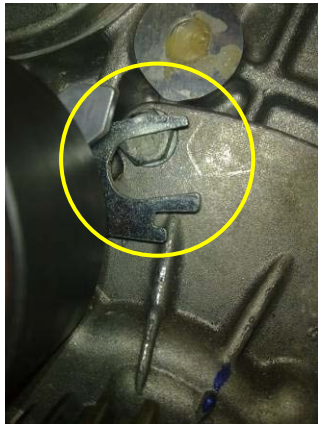
Fig. 5

If the tensioner is torqued up while the locating lug is sitting on the bolt's head (Fig. 5 and 6), this will lead to a deformation of the lug (Fig. 7), an incorrect torque of the tensioner bolt and possible tensioner misalignment.

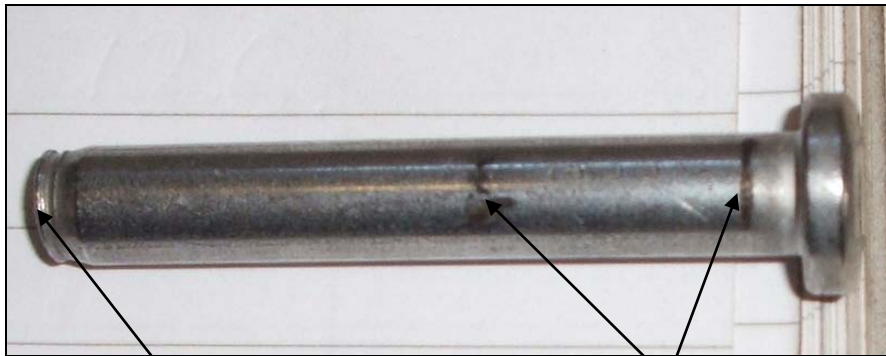
Fig. 8

The incorrect (too low) torque can lead to the bolt coming undone (due to vibrations) resulting in the load being transferred to the mounting bolt shank, causing it to shear (Fig. 8).

Bolt sheared off

Tensioner contact marks

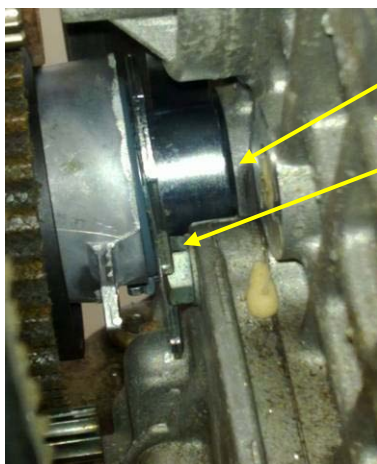
Fig. 9

Even if the locating lug is over the correct bolt head, it is possible the tensioner does not sit perfectly against the engine block after the tensioner bolt is torqued, leaving a gap between the tensioner and the engine block (Fig. 9). This will also lead to the same issues later on.

Gap

Not far enough over bolt head

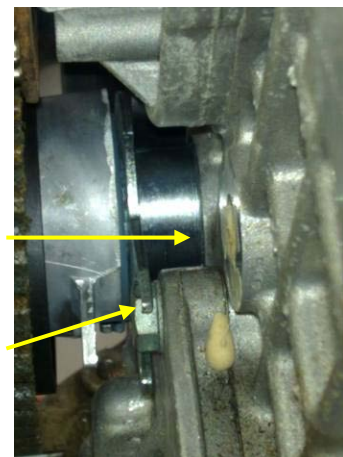
Fig. 10

No gap

Good position

Tighten tensioner bolt finger tight, assuring tensioner is in the correct position (Fig. 10).

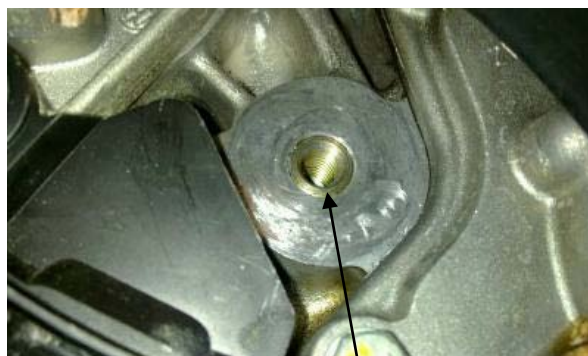
Fig. 11

- deformation of the tensioner leading to overheating of the bearing
- damage of the thread in the alloy engine block, leading to the need of a thread repair (Fig. 11)
- bolt rupture

Repaired thread

Make sure thread in engine block is still OK.

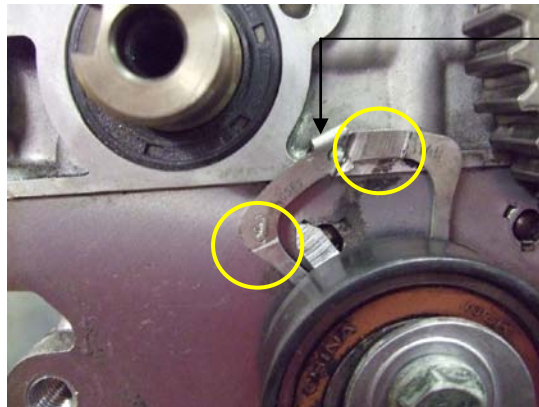
Fig. 18

In one case the tensioner was mounted upside down, with the locating lug trapped behind a part of the cylinder head at 11 o'clock (Fig. 18). When bolting on the tensioner, the back plate deformed, because there was no hole for the lug to fit in.

Locating lug

As a result, the left hand side cam sprocket and the timing belt were touching the back plate, and the belt edge was 'eaten' away until the belt broke. The marks on the tensioner back plate (Fig. 18) and the debris on the inside of the drive cover (Fig. 19) were the clear witnesses of this destruction process.

- the locating lug is placed in the hole in the cylinder head at 6 o'clock (Fig. 17).
- the tensioner is turned anti-clockwise until the pointer is in line with the positioning lug
- the tensioner bolt is torqued to 20 Nm
- the engine is turned 2 revolutions to TDC and pointer position verified (adapt if needed).
