Technical Bulletin

Tension setting on Mitsubishi/Volvo 1.8 16V petrol engines

5514XS/K015514XS

MITSUBISHI / VOLVO

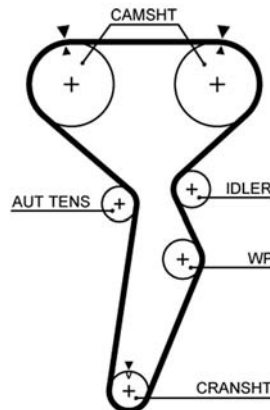
Fig. 1 shows the drive lay out of this engine, with correct position of the timing marks.

Put engine at Top Dead Centre (TDC), with Timing Marks (TM) aligned (see Fig. 1) by rotating the crankshaft clockwise.

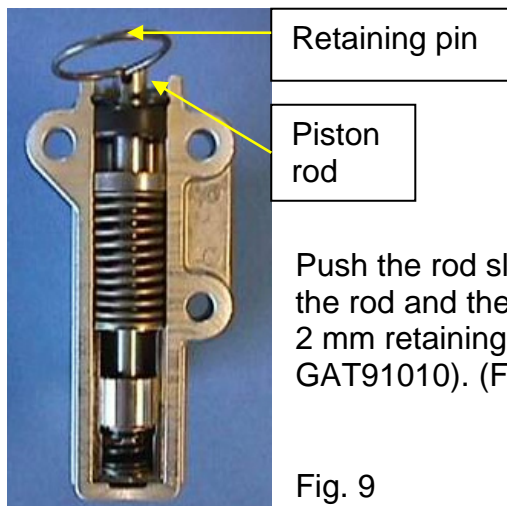
Fig. 9

By now, the piston rod of the hydraulic tensioner has come out of the tensioner body by 10.5 to 11.5 mm. If not, or leakage is present, replace the tensioner.

Apply a pressure of 10 to 20 Kg on this rod; movement of the rod should be maximum 1 mm. If more, replace the tensioner.

Push the rod slowly down (vertically) until the holes of the rod and the tensioner body are in line. Insert a 2 mm retaining pin (can be found in GAT4657 or GAT91010). (Fig. 9)
