# Technical Bulletin

## Timing belt/kit installation on VAG 1.4/1.6 16V

<b>MAKE :</b>	AUDI, SEAT, SKODA, VOLKSWAGEN	
<b>MODEL :</b>	Various	
<b>ENGINE :</b>	1.4 16V, 1.6 16V	
<b>ENGINE CODE :</b>	Various

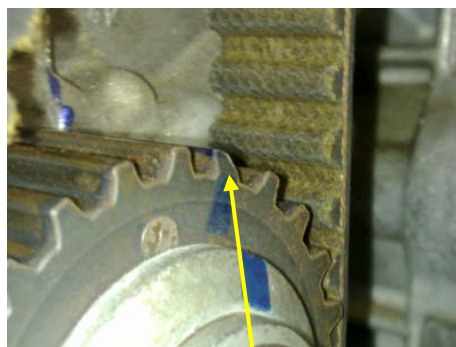
Fig. 12

Slanted tooth of the crankshaft pulley (Fig. 12) has to be in line with right hand positioning rib (Fig. 13).

Slanted tooth

Put engine at Top Dead Centre (TDC).

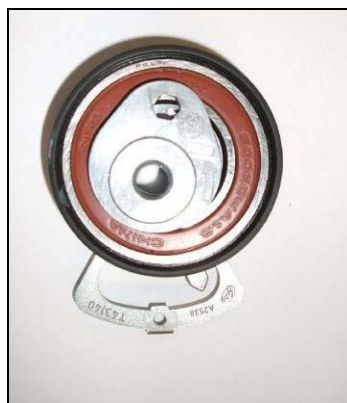
Fig. 16 shows the automatic tensioner for the cam to cam drive.
